# **Intel<sup>®</sup> Mobile Pentium<sup>®</sup> II Processor Specification Update**

Release Date: September 2000

Order Number: 243887-024

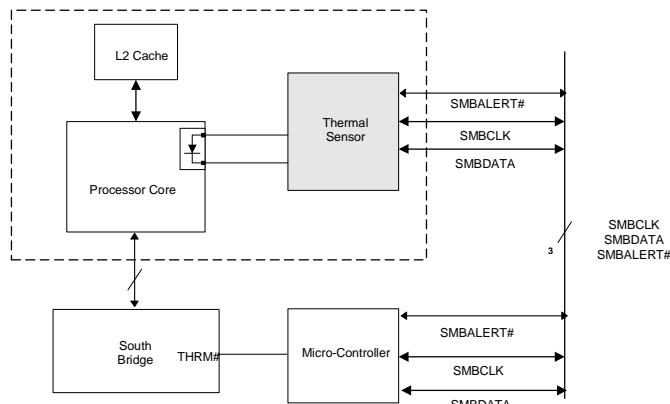
**Figure 1. An Example of Microcontroller Driven Thermal Management**

**Problem:** The Mobile Pentium II processor and the Pentium II Processor Mobile Module have a thermal sensor that monitors the processor core's temperature. Please note that desktop systems could have a similar thermal device. The thermal sensor asserts SMBALERT# if the processor temperature exceeds the temperature limits set in the Alarm Threshold Registers ( $T_{HIGH}$ ,  $T_{LOW}$ ). It also sets the corresponding Status Register bits to identify the cause of the interrupt. Figure 1 gives one example of the how the SMBALERT# signal could be used in a system.

Under the conditions described below, the thermal sensor incorrectly generates the SMBALERT# interrupt. All of the following conditions must be met to trigger a false interrupt:

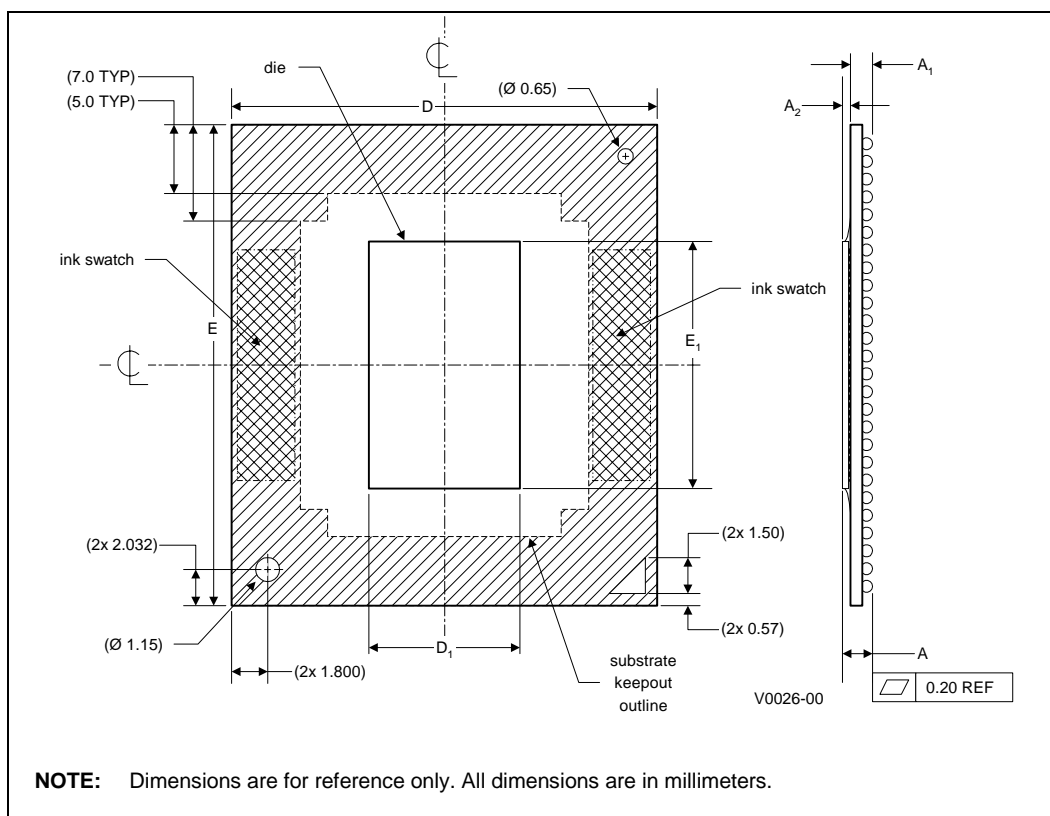
**Figure 5.3. Surface-Mount BGA1 Package—Top and Side View**

The following table and figures show the updated mechanical specifications for the BGA1 package, listed as Table 5.2, Figure 5.3 and Figure 5.4, respectively, in the *Mobile Pentium® II Processor in BGA Package at 366 MHz, 333 MHz, 300PE MHz, and 266PE MHz* datasheet.

1. The number shown here is different from that in the 243887-010 revision of this specification update. The maximum reference number is used.

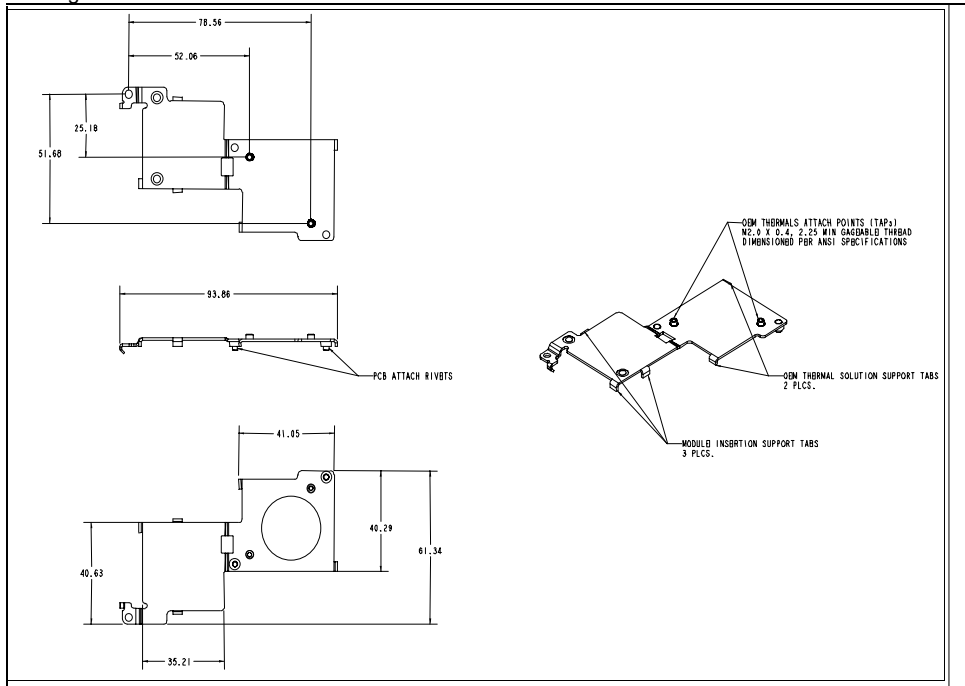
Figure 1. TAP Gageable Thread Clarification

OEM Thermal Attach Points (TAPs) M2.0 x 0.4, 2.25 min gageable thread dimensioned per ANSI specification.

See Figure 1 below for more information.
